Manhole Inspection Summary

Manhole # S29K__055MH

Location Address: **Washington Blvd.**

Cross Street: **MLK Jr. Blvd.**

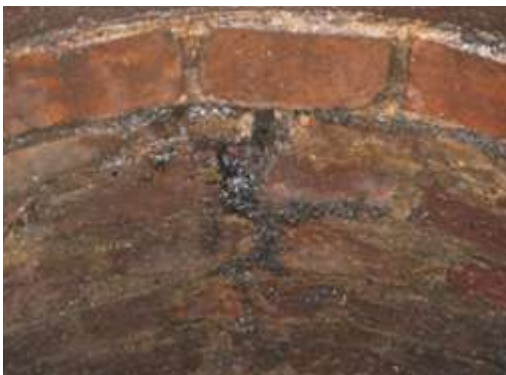
misc-6

Infiltration: ☐ None ☐ Joint ☐ Cracks ☐ Mortar ☐ Roots ☒ **Wall**

Condition: ☐ Sound ☒ **Cracked** ☐ Root Intrusion ☐ Loose Brick ☐ Deteriorated

Infiltration: ☐ None ☐ Joint ☐ Cracks ☒ **Mortar** ☐ Roots ☒ **Wall**

chimney infiltration and corbelinfiltraton
with cracked brick and missing mortar

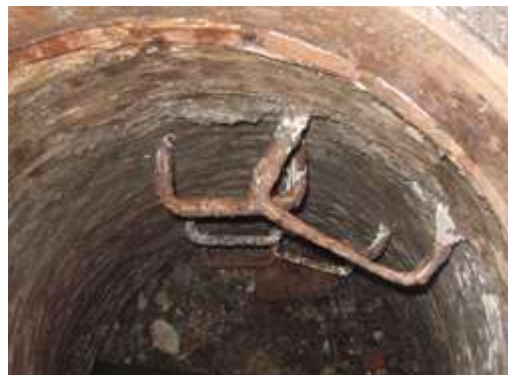
misc-5

Condition: ☐ Sound ☐ Cracked ☐ Root Intrusion ☐ Deteriorated ☐ Leaks ☒ **Debris**

Steps Count: **6** Missing: **0** ☒ **Corroded**

corroded steps & bench debris

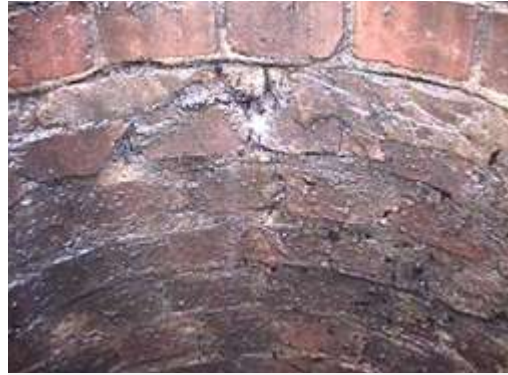
Defect 7

corbel bricks cracked as well as mortar missing

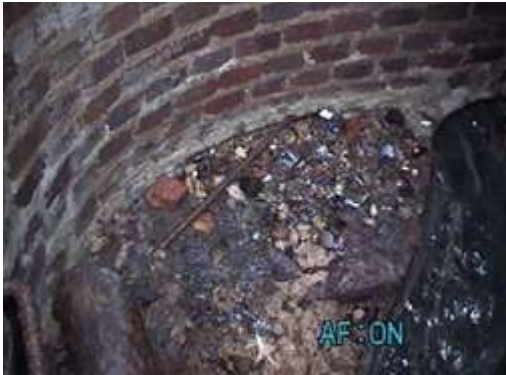
Defect 6

debris on bench

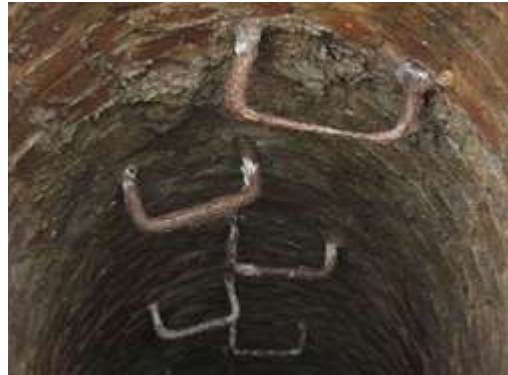
Defect 5

corroded rungs

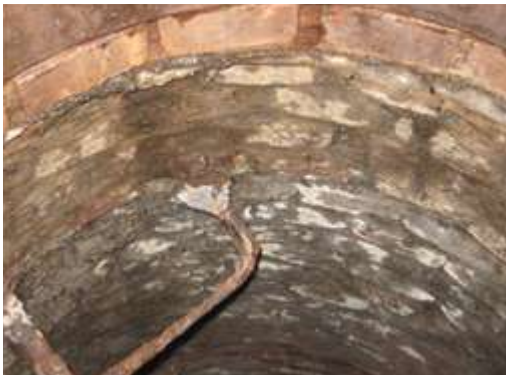
Defect 4

corbel infiltration at mortar & wall

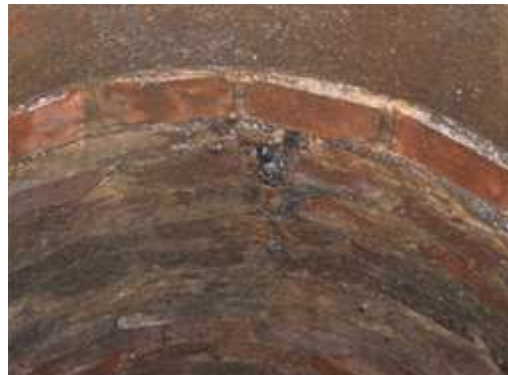
Defect 2

infiltration at chimney wall

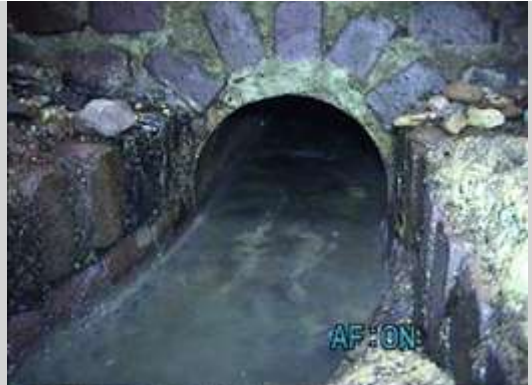
12 O'Clock Outflow

Pipe Height: **10.8** (in.) Rod and Bar (Angled)
Pipe Material: **Clay** ☐ Pipe Lined
Invert Depth: **11.98** (ft.) Flow Characteristics: **Slow**
Deposits: ☐ None ☒ **Mud** ☒ **Sludge** ☐ Debris ☐ Grease
Silt Depth: **2** (in.) Deposits Extent: **Medium**
Infiltration: **None** Pipe Seal Cond: **Sound**

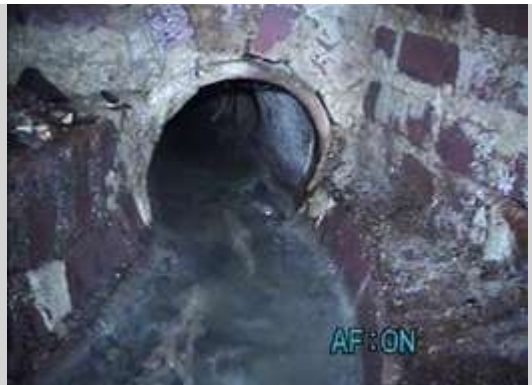
7 O'Clock Inflow

Pipe Height: **10.8** (in.) Rod and Bar (Angled)
Pipe Material: **Clay** ☐ Pipe Lined
Invert Depth: **11.96** (ft.) Flow Characteristics: **Slow**
Deposits: ☐ None ☒ **Mud** ☐ Sludge ☐ Debris ☐ Grease
Silt Depth: **1** (in.) Deposits Extent: **Medium**
Infiltration: **None** Pipe Seal Cond: **Sound**
